BIOS Release Notes

SUBJECT: MZ31-AR0 BIOS Release Notes version [R40](#)
System: [G221-001-AM](#), [G221-Z30-00](#), [G221-Z30-ES-Waseda-001](#), [MZ31-AR0-00](#),
[R151-001-00](#), [R151-Z30-00](#), [R151-Z31-00](#), [R151-Z32-00](#),
[R270-Z30-ES-AMD-001](#), [R271-Z31-00](#), [R271-Z31-ES-AMD-001](#), [S451-Z30-00](#)

Build Date: [2024/10/11](#)
BIOS Checksum: [0xCCFFE51C](#) (16M)
Release Owner: Terry.Chuang

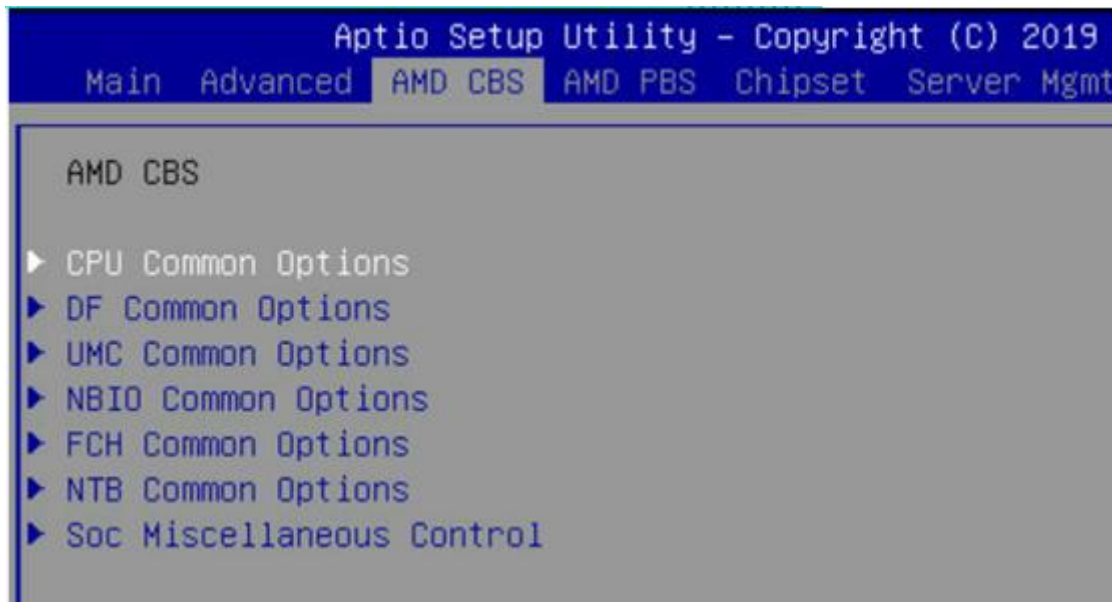
BIOS setup item "SMT Mode" Location as below :

AMD CBS (on BIOS Setup page bar)

- ▶ CPU Common Options
 - ▶ Performance
 - ▶ CCD/Core/Thread Enablement
 - ▶ Accept
- SMT Control: Disable (Default) / Auto

BIOS setup item "SMT Mode" meant (Simultaneous Multi-Threading) Technology.
